16 October 2003

Contract No. 68-W-00-119  
TDD No.: S05-0301-007  
DCN: 338-2A-ADMC

Subject: Letter Report of Results of Asbestos Sampling  
IWI, Inc. Site  
Summit, Cook County, Illinois

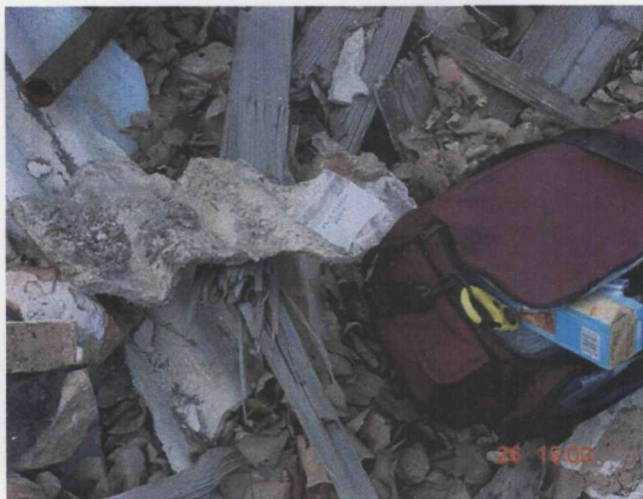
**PHOTO NO:** 1

- The suspect transite tiles in the debris pile (Sample IWI-032603-A01) south of the Stack Building (Photos 1 and 2);
- The insulation (Sample IWI-032603-A02 to A04) on the railroad tanker car that is parked to the west of the Stack Building (Photo 3);

- The transite tiles (Sample IWI-032603-A01) in the debris pile south of the Stack Building (60% chrysotile);
- The insulation (Sample IWI-032603-A02 to A04) on the railroad tanker car that is parked to the west of the Stack Building (5% chrysotile);
- The aircell insulation (Sample IWI-032603-A05) on the doors to the boilers in the Stack Building (55% chrysotile);
- The packing material (Sample IWI-032603-A06 to A08) in the boilers (55-60% chrysotile);
- The insulation (Sample IWI-032603-A09) on the fire door on the south wall of the Boiler Room in the Stack Building (45% chrysotile); and
- The wrap (Sample IWI-032603-A14) on the steam pipe on the second floor of Room 4 of the Main Building (45% chrysotile).

**SUBJECT:** Transite tile in debris pile south of Stack Building. Sample collected here: IWI-032603-A01

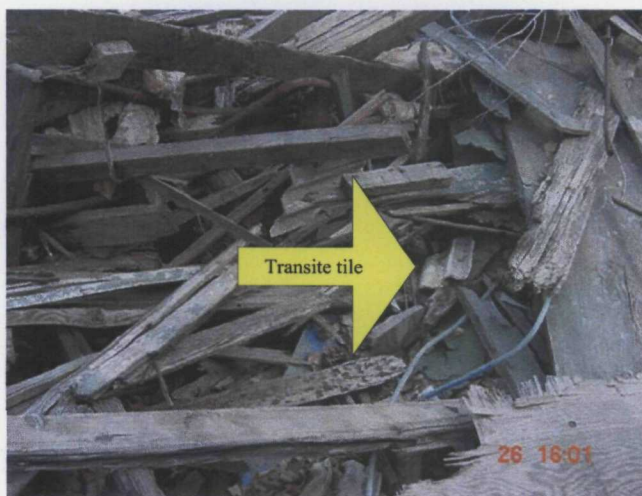
**PHOTO NO:** 2

**SUBJECT:** Pile of demolition debris on site, south of Stack Building. Notice transite tile in center of photo.

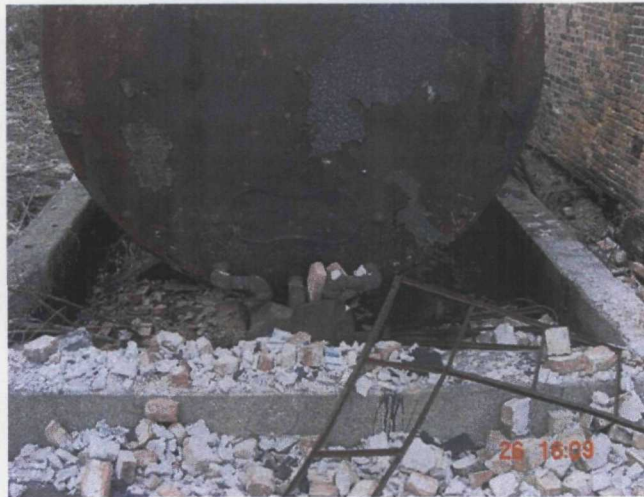
**PHOTO NO:** 3

**SUBJECT:** Railroad tanker car with PACM coating on it. Samples collected here for asbestos: IWI-032603-A02, IWI-032603-A03, and IWI-032603-A04.

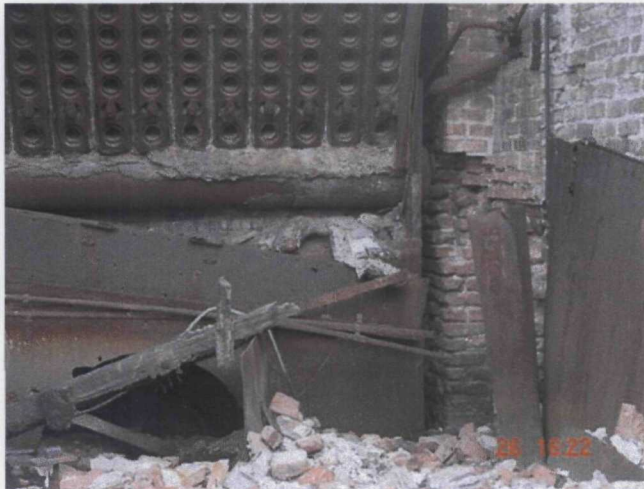
**PHOTO NO:** 4

- The suspect air-cell insulation (Sample IWI-032603-A05) on the doors to the boilers in the Stack Building (Photos 4 and 5);
- The packing material (Sample IWI-032603-A06 to A08) in the boilers (Photo 4);

**SUBJECT:** South boiler in Stack Building with PACM insulation in boiler and air cell in door. Samples IWI-032603-A05 (aircell) and IWI-032603-A06 (insulation) collected here.

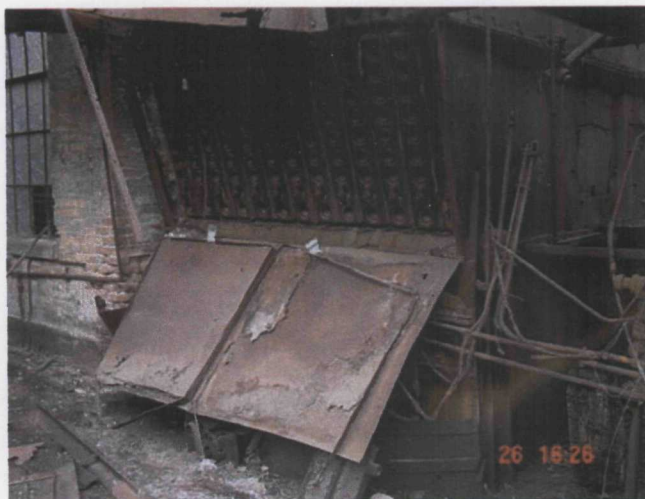
**PHOTO NO:** 5

**SUBJECT:** North boiler in Stack Building. Insulation samples IWI-032603-A07 and IWI-032603-A08 collected here.

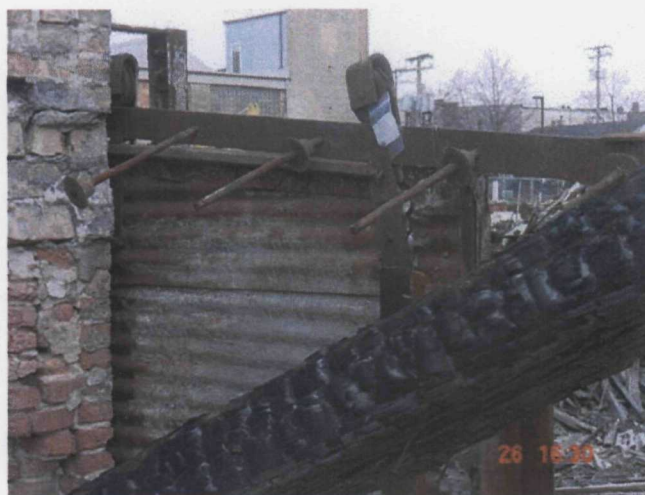
**PHOTO NO:** 6

- The insulation (Sample IWI-032603-A09) on the fire door on the south wall of the Boiler Room in the Stack Building (Photo 6);
- The wrap (Sample IWI-032603-A14) on the steam pipe on the second floor of Room 4 of the Main Building (Photo 13);

**SUBJECT:** Fire door on south wall of Stack Building that contains PACM. Sample IWI-032603-A09 collected here.

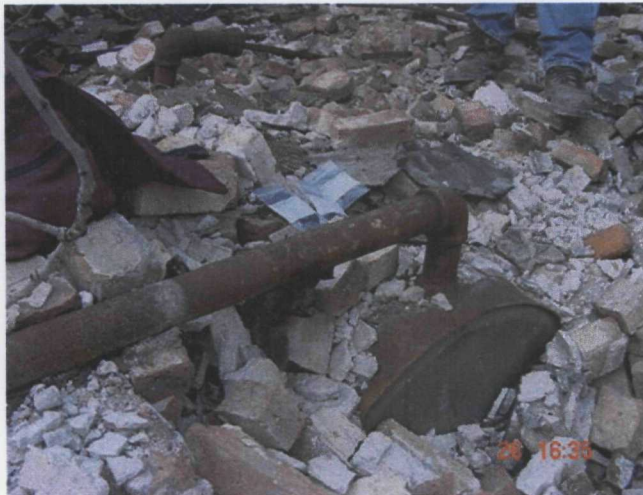
**PHOTO NO:** 7

- The insulation (Sample IWI-032603-A10 to A12) on the day tank in the southwest corner of the Boiler Room in the Stack Building (Photo 7);
- The roofing tar paper (Sample IWI-032603-A13 to A15) that was collected from the floor of Room 5 of the Main Building (Note: Direct sampling of the roofing material was not possible given the that all structures on site were in imminent danger of collapse. All roofing material was presumed to be non-friable asbestos containing material.);

**SUBJECT:** Partially buried day tank in southwest corner of boiler room in Stack Building with PACM insulating cover. Samples IWI-032603-A10, IWI-032603-A11, and IWI-032603-A12 sampled here.

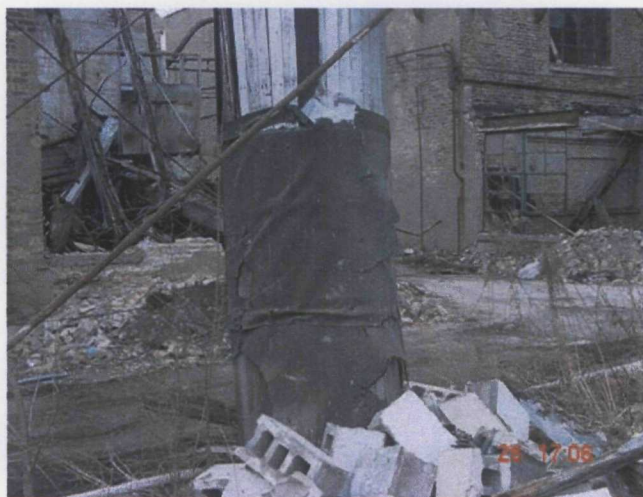
**PHOTO NO:** 8

- The tar paper insulation (Sample IWI-032603-A16 to A18) on the water tower downpipe (Photo 8);
- Three components of the chimney in the Stack Building were sampled (Photos 9-12):

**SUBJECT:** Tar paper wrap on water tower downtube. Samples IWI-032603-A16, IWI-032603-A17, and IWI-032603-A18 were collected here.

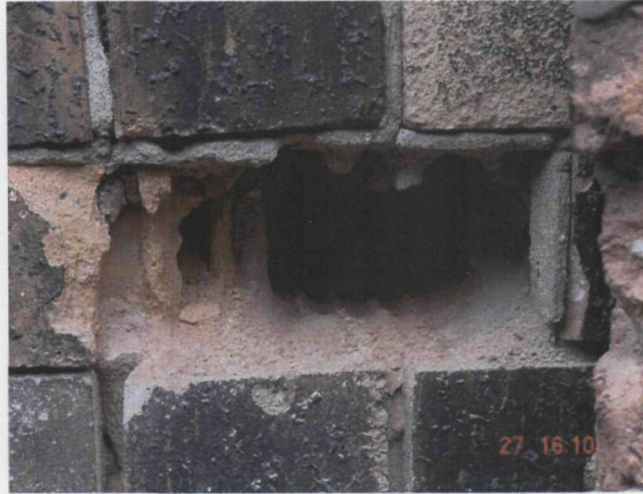
**PHOTO NO:** 9

- Bricks (Sample IWI-032703-A03, A04, and A07);
  - Mortar (Sample IWI-032703-A05, A06, and A08); and
  - Insulation between the inner and outer bricks in the chimney (Sample IWI-032703-A01, A02, A09, and A10).

**SUBJECT:** Inside of hole in chimney of Stack Building that was made for asbestos sampling, west side of chimney.

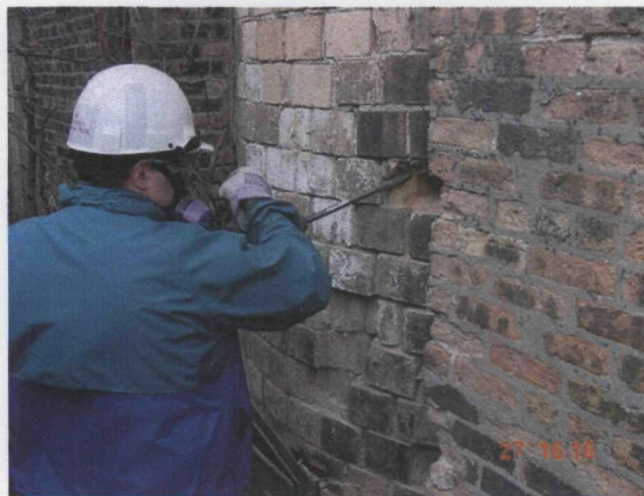
**PHOTO NO:** 10

**SUBJECT:** START Wojcik using power hammer to cut into west side of chimney of Stack Building for asbestos sampling.

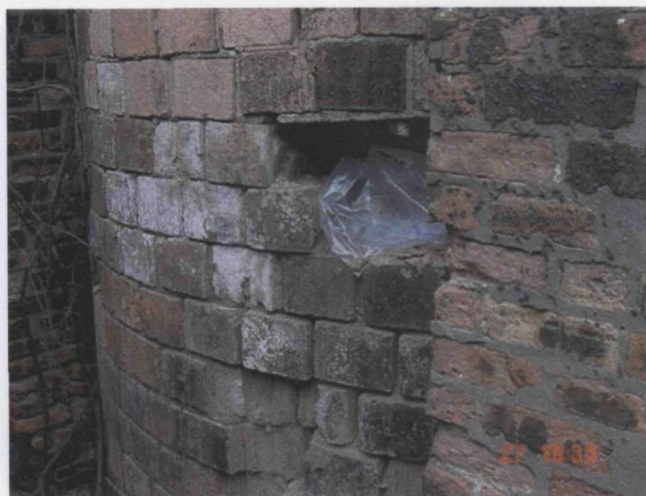
**PHOTO NO:** 11

**SUBJECT:** Samples taken of insulation, brick, and mortar on west side of chimney of Stack Building, samples IWI-032703-A01 through -A06.

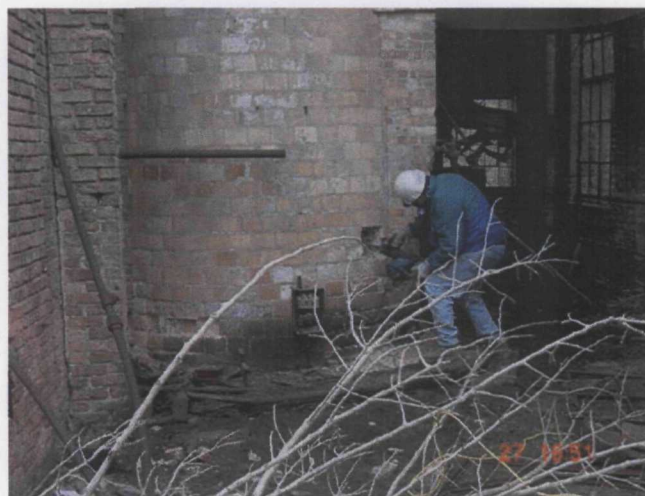
**PHOTO NO:** 12

**SUBJECT:** START Wojcik using power hammer to cut into east side of chimney of Stack Building for asbestos sampling.

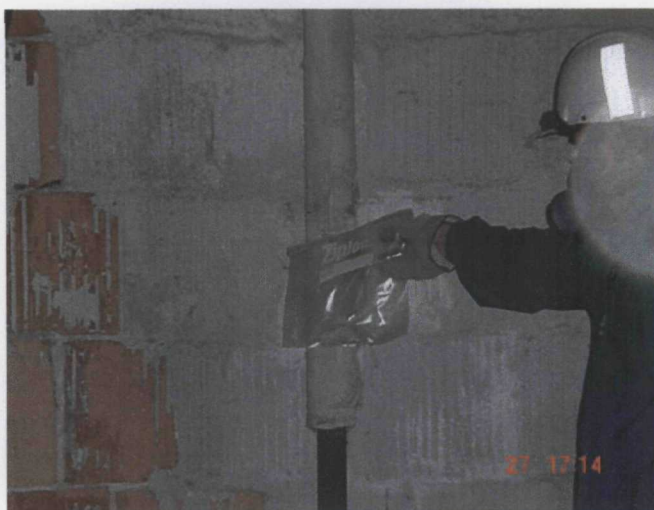
**PHOTO NO:** 13

**SUBJECT:** Sample of pipe wrap for asbestos content, second floor of Room 4 of Main Building, west end. Sample IWI-032703-A14.
